**BLACKSTONE RIVER BASIN
WORCESTER, MASSACHUSETTS**

**WILLIAMS MILL POND DAM
MA 00121**

PHASE I INSPECTION REPORT NATIONAL DAM INSPECTION PROGRAM

APRIL 1979

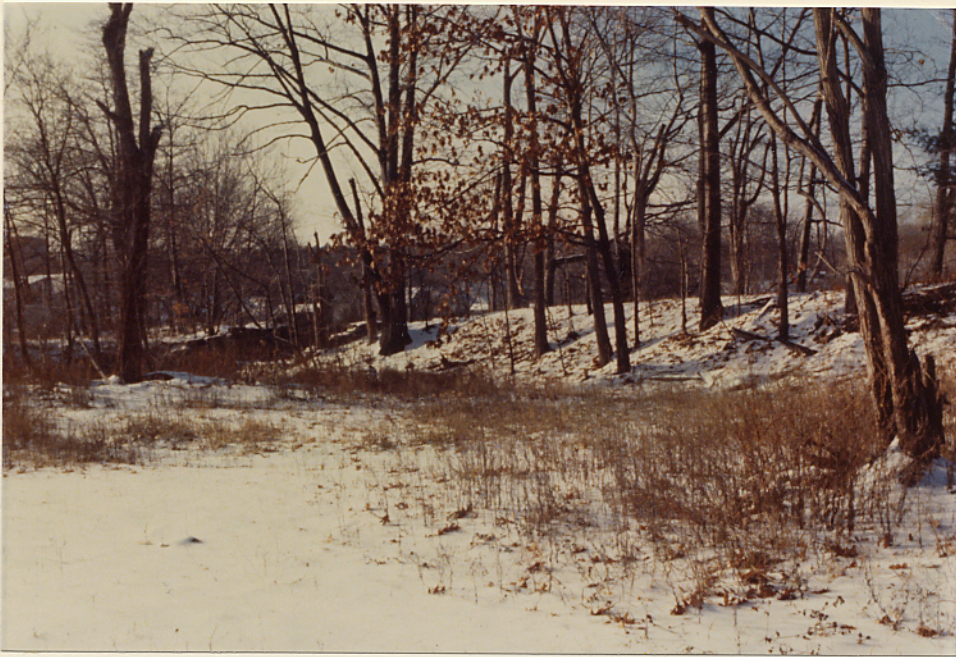
- b. Dam. Williams Mill Pond Dam consists of an earth embankment with a central masonry spillway. The embankment is in fair to poor condition. Both the upstream and downstream slopes and the crest of the dam are overgrown with thick vegetation, including trees up to 2 feet in diameter. The trees have formed a network of roots that are now exposed on the narrow, uneven crest. There is no riprap visible on the upstream slope of the dam. The areas of local erosion on the upstream slope appear to be due to surface runoff rather than wave action, particularly in the area adjacent to the spillway training walls.

NO. 1 DOWNSTREAM VIEW OF LEFT EMBANKMENT

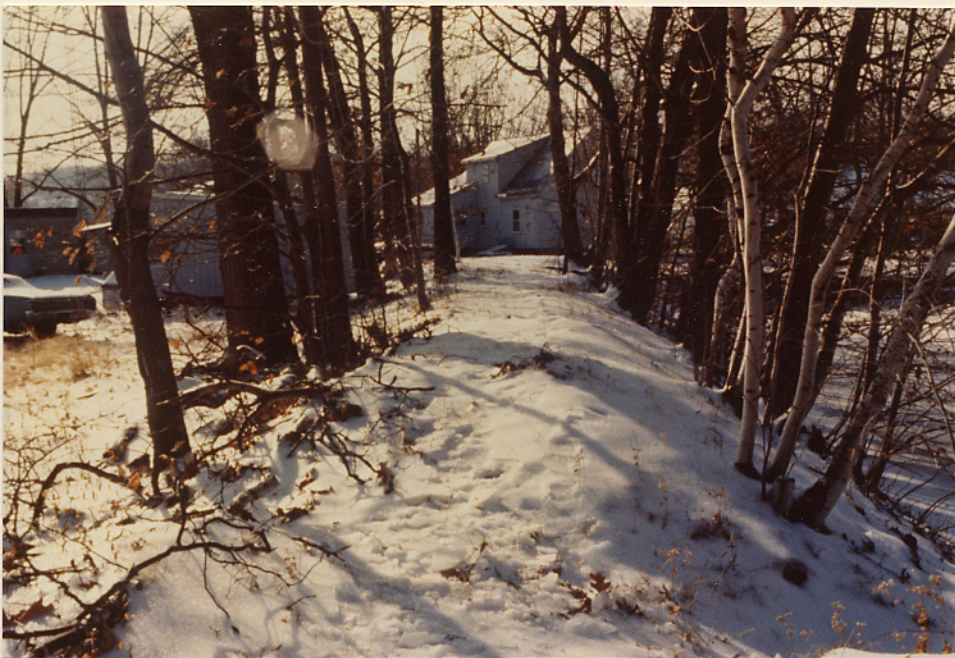
NO. 2 CREST OF RIGHT EMBANKMENT

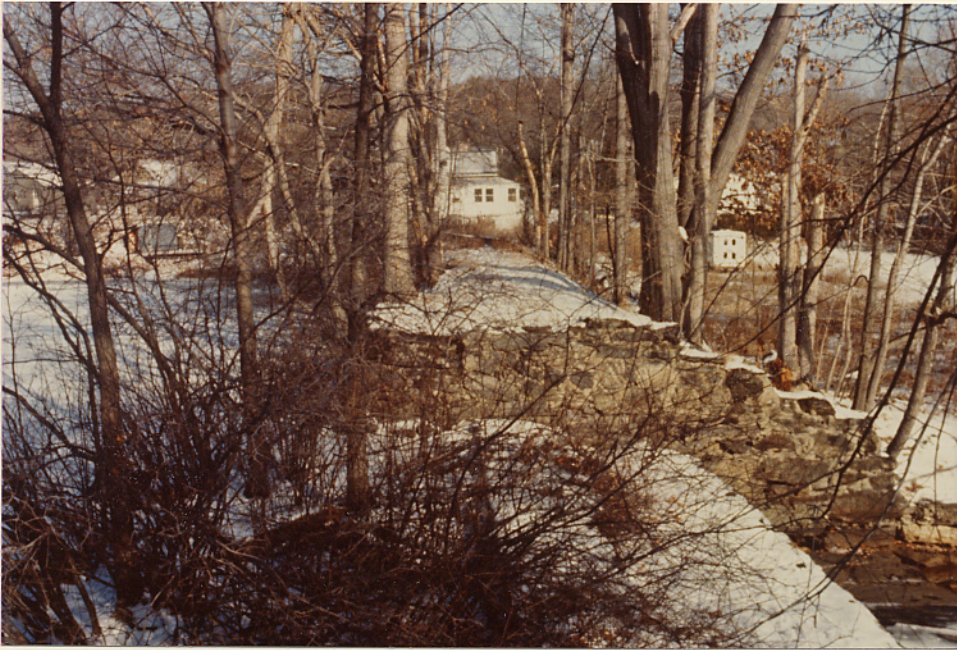
NO. 3 SPILLWAY AND LEFT EMBANKMENT

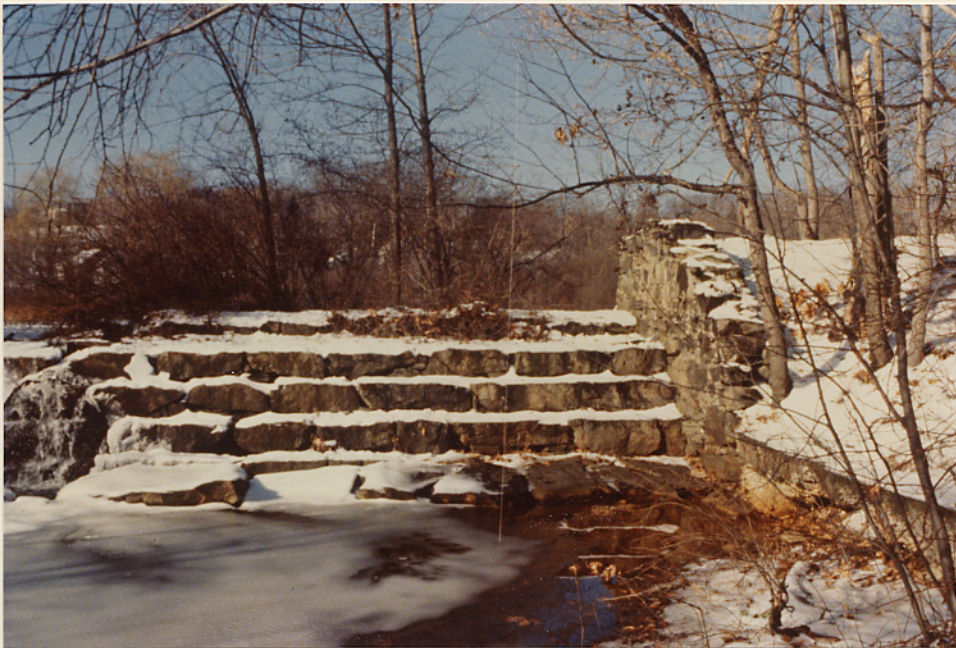
The stepped stone cascade is in fair condition. However, the broad flat blocks which form the apron at the toe of the weir are tilted, probably due to erosion of the underlying material.

NO. 4 SPILLWAY CASCADE AND LEFT TRAINING WALL

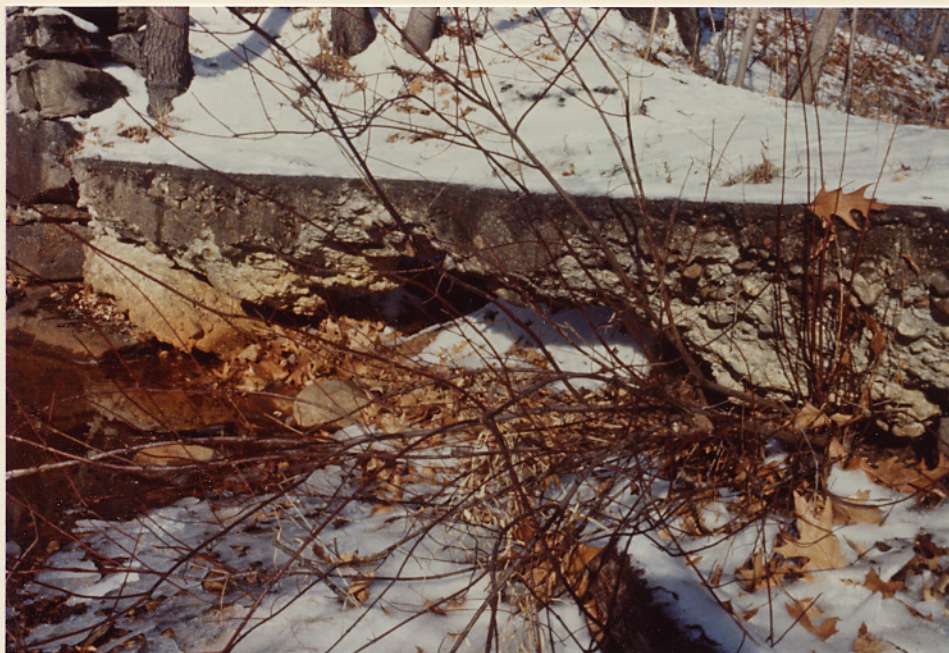
The left stone side wall ends at the toe of the spillway and is replaced by a low concrete wall. The wall no longer marks the left side of the channel but extends into the woods below the left embankment for a distance of 105 feet.

**NO. 5 EROSION OF CONCRETE WALL ON
LEFT BANK OF DISCHARGE CHANNEL**

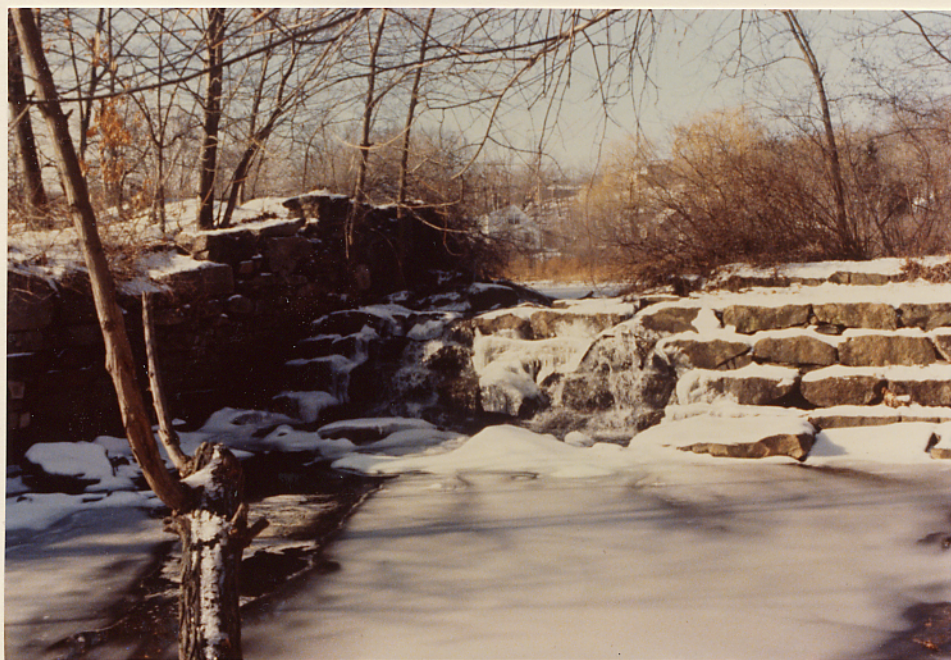
The approach to the narrow-crested weir is overgrown with brush and trees up to 10 inches in diameter. The concrete cap to the weir is barely visible through the brush, but that portion that remains appears to be in fair condition. Two iron pins set in the concrete are rusted and bent. The concrete cap is missing in the breached portion of the weir, exposing the underlying blocks of stone.

The training walls on the spillway are in poor condition. The base of the walls on the approach are out of alignment. Patches of loose grout remain between some of the stones but generally the mortar is missing entirely. A few large stones have fallen out of the base of the right wall and form part of the rubble on the breached section of the crest.

**NO. 6 BREACHED SECTION OF SPILLWAY
AND RIGHT TRAINING WALL**
